# Manhole Inspection Summary

Manhole # S19II\_007MH

Insp Date: **6/21/07 11:44 AM**

**Location** Address: **2000 PRESBURY ST**

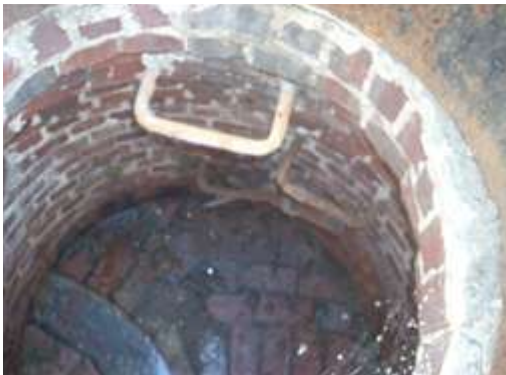
Defect 2

**Steps** Count: **3** Missing: **0** ☒ **Corroded**

CORRODED STEPS

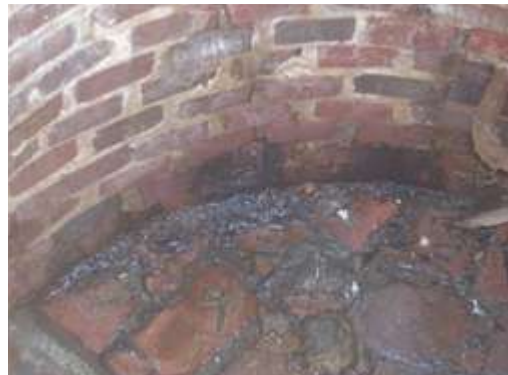
Defect 3

Infiltration: ☐ None ☐ Joint ☐ Cracks ☐ Mortar ☐ Roots ☒ **Wall**

BARREL INFILTRATION

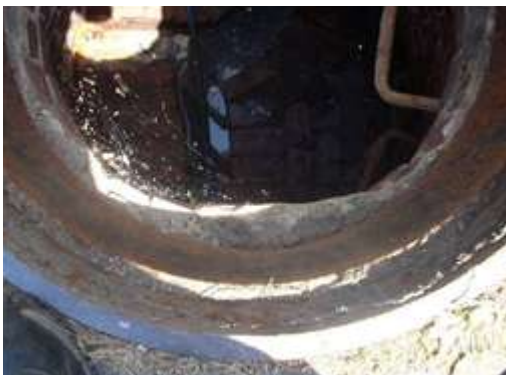
Defect 1

**Frame** Offset: **2** (in.) Condition: ☒ Sound ☐ Cracked ☐ Leaks

FRAME OFFSET

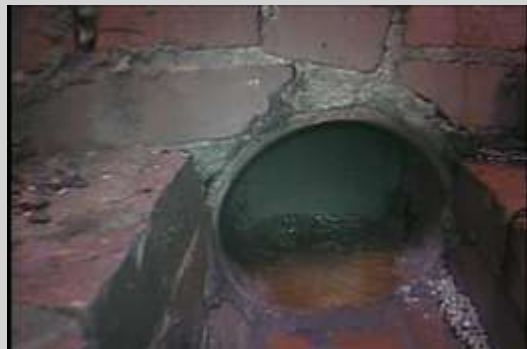
9 O'Clock Inflow

Deposits: ☐ None ☐ Mud ☐ Sludge ☒ **Debris** ☐ Grease

Silt Depth: **3** (in.) Deposits Extent: **Light**
